South Forty Foot Drain, Boston and the South Forty Foot Drain Fens

Flooding 6th to 7th January 2025 – Evidence Based
Review

Date: 9th May 2025

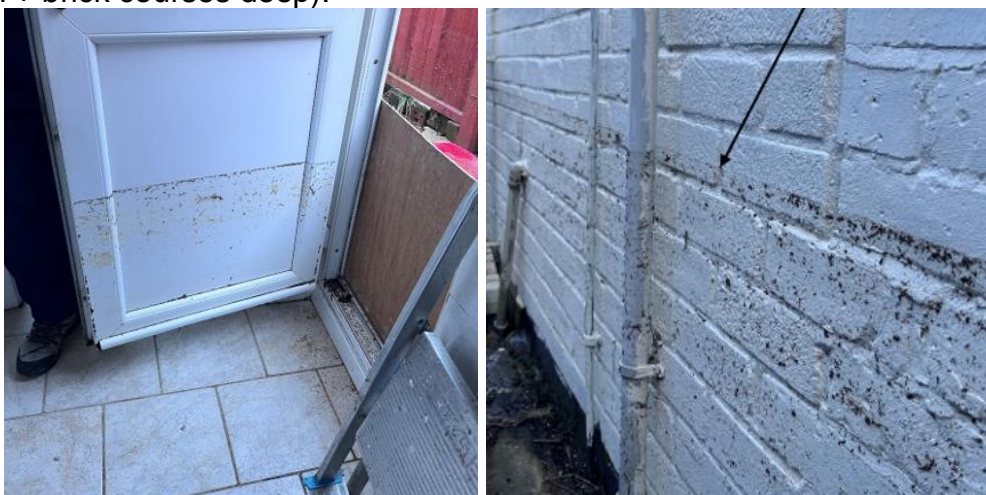
- Floodwater was observed entering one home adjacent to the South Forty Foot Drain, at the end of the road near to the flood wall at about 23:30 on 6 January. By around 04:00 on 7 January, the resident said the water was mostly gone leaving wet floors / carpets. It had reached levels internally of around 0.3m. The flood or 'wrack' marks outside in the back garden indicated deeper water of around 0.5m (7+ brick courses deep).

- It appears most houses impacted by internal flooding were on the north side of Wyberton West Road adjacent to the South Forty Foot Drain with those opposite having water reaching their houses but no water ingress.
- Properties in Park Road which joins Wyberton West Road at a slightly lower point, also suffered internal flooding presumably as water flowed through the lowest land.
- Some houses were impacted more significantly than others, according to one resident who said whilst they had water in their house, they felt they got off lightly compared to others.
- One elderly couple advised they had lived in the same house for 57 years and this is the first time they have flooded. They were in the process of cleaning up and moving out.
- Residents believed water from the South Forty Foot Drain had overtopped the areas of 'low walls' at the back of properties.

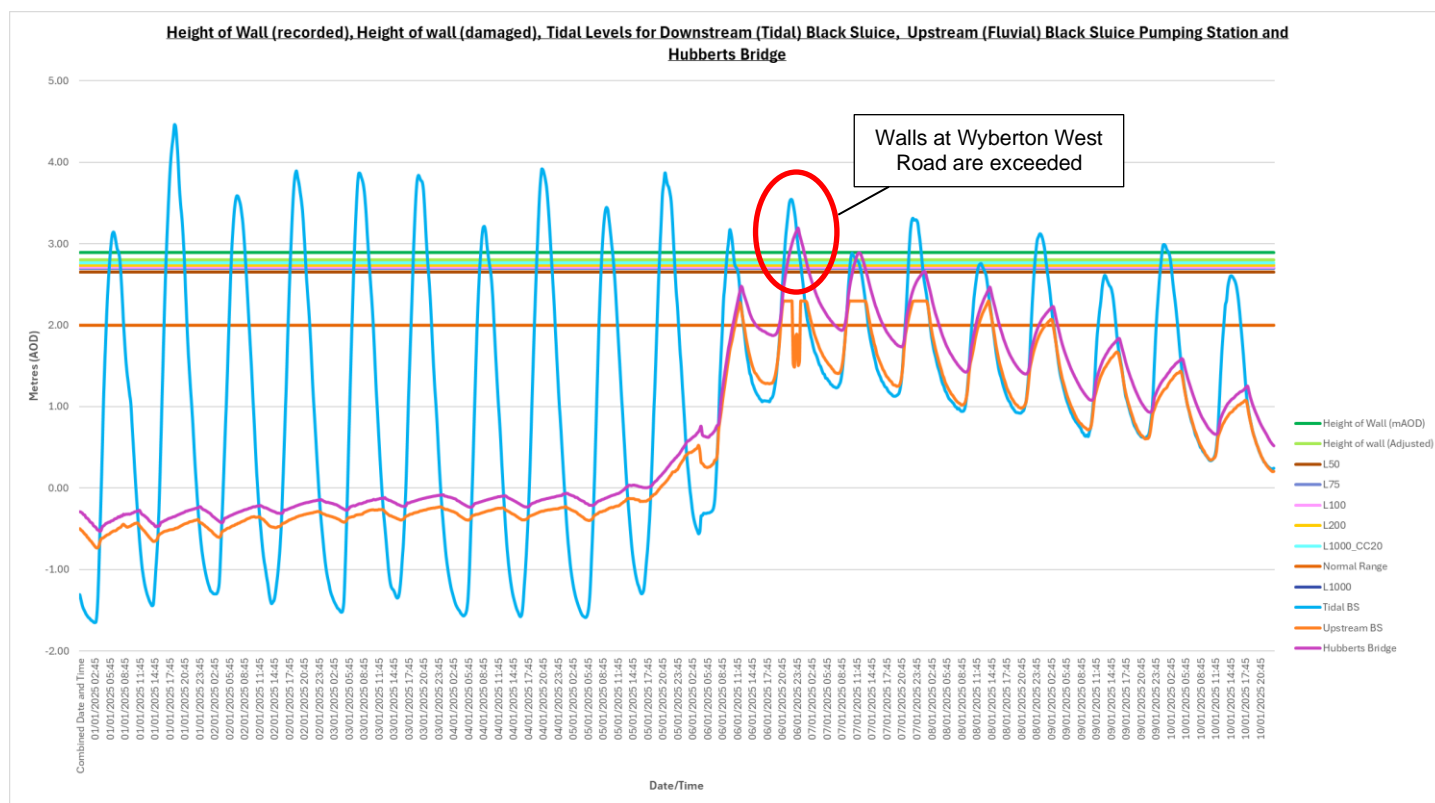
Figure 17 – South Forty Foot Drain actual river levels against recorded and indicative wall height bank levels

Figure 17 below shows the modelled and actual river levels from 01/01/2025 to 10/01/2025. Flood wall levels at Boston to the rear of Wyberton West Road are also included.

The Black Sluice Catchment model 2016 shows that river levels at Hubbert's Bridge Gauging Station on the 6th January 2025 peaked at 0.428m above the modelled level of 1:1000 (0.1%) chance of occurring in any one year plus a climate change allowance. This river response is not typical, and the fact flooding has not previously been recorded in this location in Boston from the river, shows the scale and magnitude the rainfall event and catchment conditions had on the South Forty Foot Drain catchment.

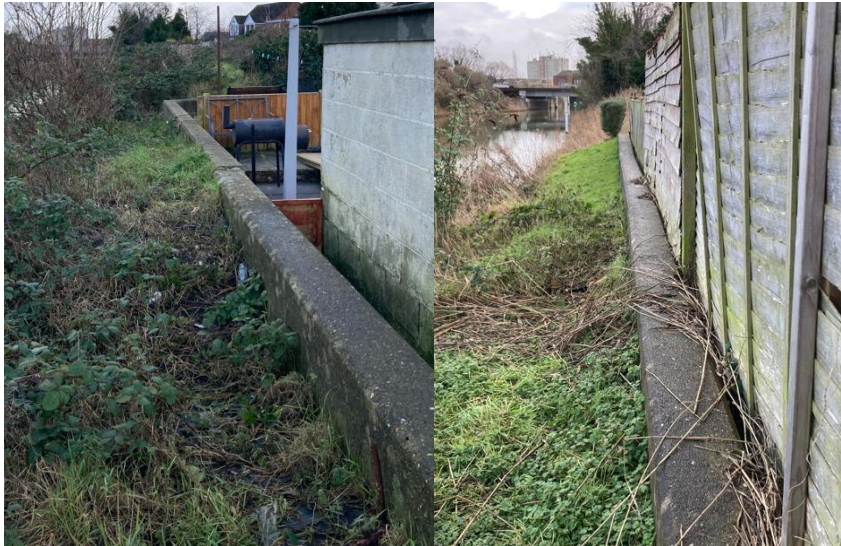
Figure 18: West (left) and east (right) flood walls, to the rear of Wyberton West Road

Two flood walls are located on top of the river embankments to the rear of Wyberton West Road. It is likely that these were constructed in the 1960s, by the Lincolnshire River Board when a large amount of investment went into the flood defences and drainage systems in the South Forty Foot Drain Catchment.

- Embankments and walls at Wyberton West Road: work required to bring these defences into a better condition has already been identified and programmed. The flooding experienced in January has provided further justification for these works to be completed as soon as possible.

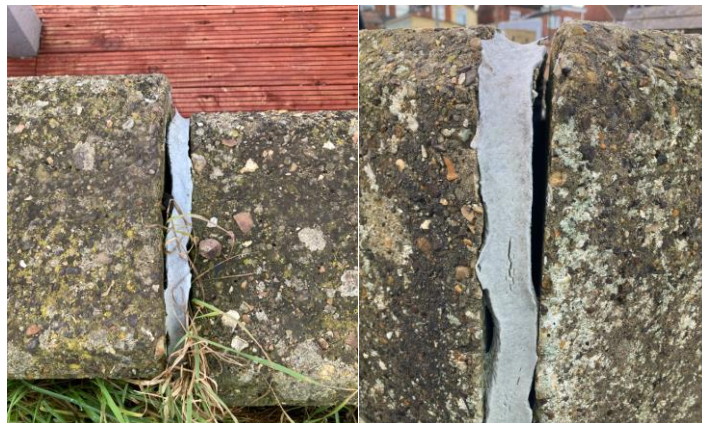
Figure 20: Wall settlement and joint failure in concrete walls.

Routine inspections, in June 2024, by the Environment Agency had reported settlement and joint failures in these walls, although works to address this issue had not yet been programmed at the time the flooding on the 6th January 2025. High water levels, against these walls, would lead to water flowing through any failed joints and there is a higher chance of overtopping taking place due to the settlement of sections of wall. Since the flooding a work order was placed for the Environment Agency's field team to reseal these joints in advance of any future works to the embankment.

- Undertake surveys, and preparation for embankment seepage and wall stabilisation works, returning wall heights to their design levels on the South Forty Foot Drain right bank in Boston.
- Replace wall joint seals. *Update 19/03/2025 joint seals have been repaired by the Environment Agency's Field Team.*
- Complete Storm Henk recovery works at Dunsby and Quadring. *Update 18/03/2025 works at these sites have now been completed.*
- Provide this review and supporting data and evidence to Lincolnshire County Council for their statutory Section 19 reporting process for flood incidents.
- Initial review of incident procedures amending if required. *Update February 2025: incident procedures updated accordingly.*

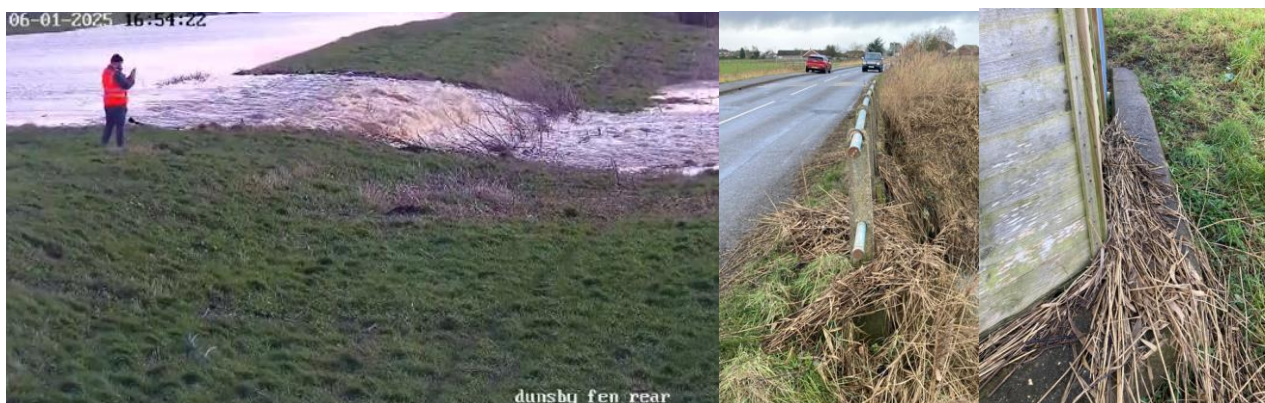
Figure 22 – Evidence of overtopping on South Forty Foot Drain – L to R (and U/S to D/S) Dunsby left bank overtopping, Chain Bridge Road right bank wrack marks on bridge railings, Boston right bank, wrack marks on walls to rear of Wyberton West Road.

There is clear evidence of overtopping of the main river defences in several locations. At Dunsby and Quadring photographs on the 6th January 2025 show the overtopping of the South Forty Foot Drain taking place. Field teams were quickly instructed by Environment Agency duty officers to attend these locations and replace temporary erosion protection measures, put in place following damage that had occurred during Storm Henk. Recovery works have been completed here in March 2025, and include permanent erosion protection to avoid future bank failures should overtopping happen again.

Eyewitness accounts, clear wrack marks (debris) and erosion damage confirm the overtopping at Chain Bridge Road, over the right bank of the South Forty Foot Drain. Further down the channel at Wyberton West Road, there were also clear wrack marks on the concrete walls located on top of the right bank, indicating overtopping here too.

- Action by Environment Agency Field Teams to replace temporary sheeting and sandbagging at Dunsby and Quadring damaged embankments, to prevent full breaches from occurring.

- Storm Henk recovery works: outstanding repair works at Dunsby and Quadring have now been completed as of March 2025.
- Incident procedures in case of asset failure have been reviewed by Environment Agency Operational staff, to assess whether any further improvements can be made to mitigate risks.

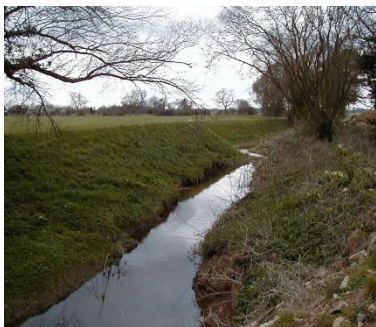
The Ouse Mere Lode, which runs to the north of Billingborough village, is a main river tributary of the South Forty Foot Drain. It carries flows from the high ground of the catchment up to 72 metres above sea level, to the South Forty Foot Drain. River levels crossing the fen in the South Forty Foot Drain to Boston can vary between 0 metres (normal levels) and 3 metres (extreme high flows) above sea level. At Billingborough the Ouse Mere Lode is around 9 to 10 metres above sea level.

The Ouse Mere Lode has a flood defence earth embankment, constructed in 2000 to offer protection to the village up to a 1 in 25 chance of flooding in any one year.
